In-service inspection of welds in atmospheric ammonia storage tanks

Ole Nørrekær Mortensen
Advanced NDT Global

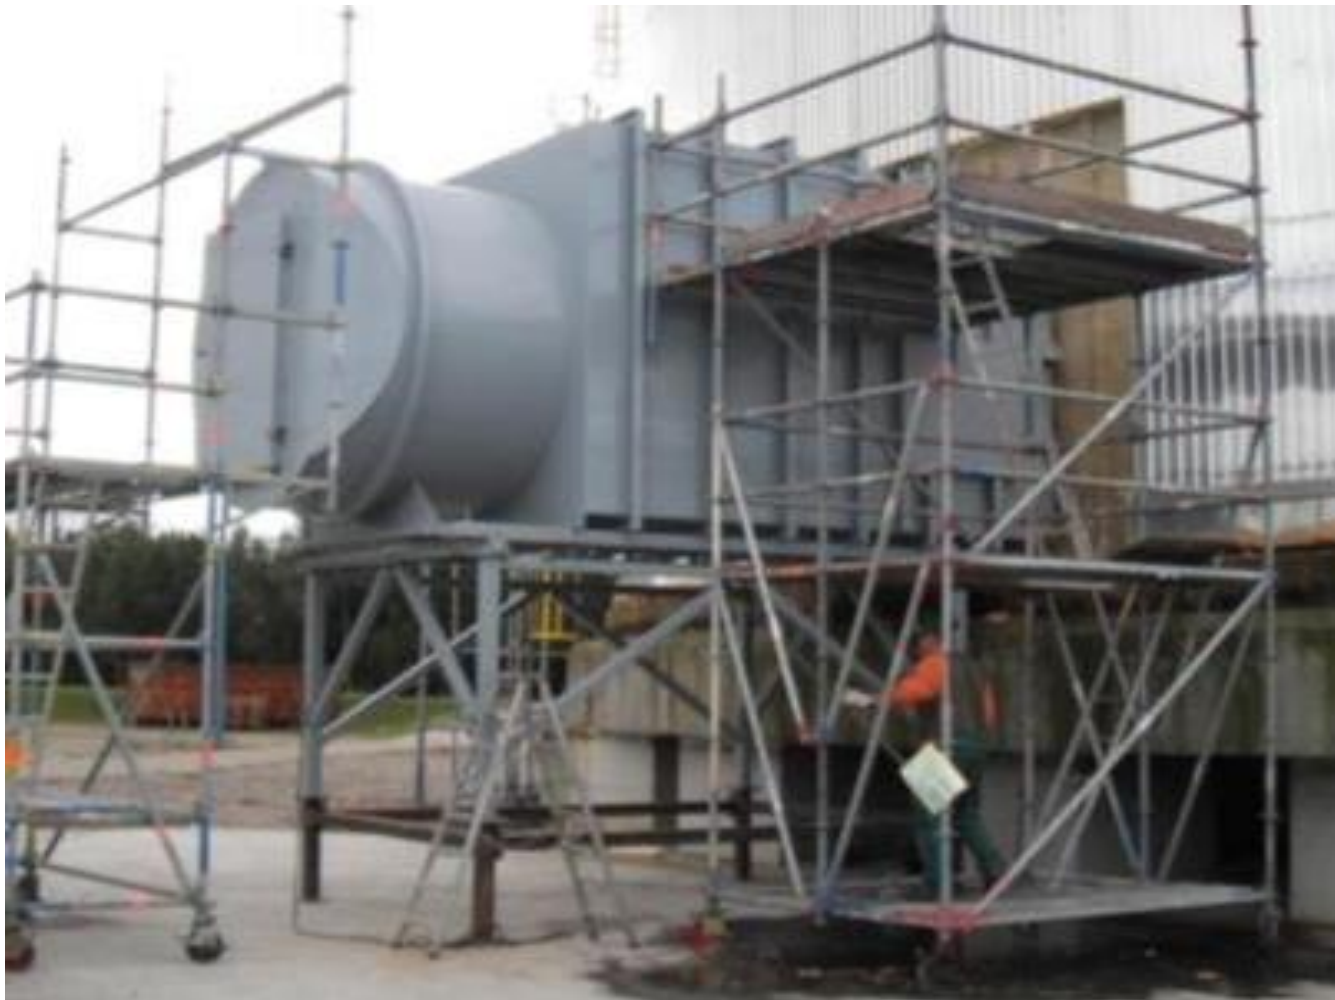
Habitat in position at outer manhole

- Ground foundation for habitat
- Placing habitat with platforms and scaffolding
- Removal of insulation from the tank manhole and cleaning of the cover
- Installation and alignment of the habitat
- Sealing around manhole
- Nitrogen supply for flushing of habitat and equipment
- Connection of oxygen analyzer
- Preparation for gas divers (fresh air supply and water supply for washing ammonia off)
- Placing container with electronics and glycol supply
- Placing container with control room

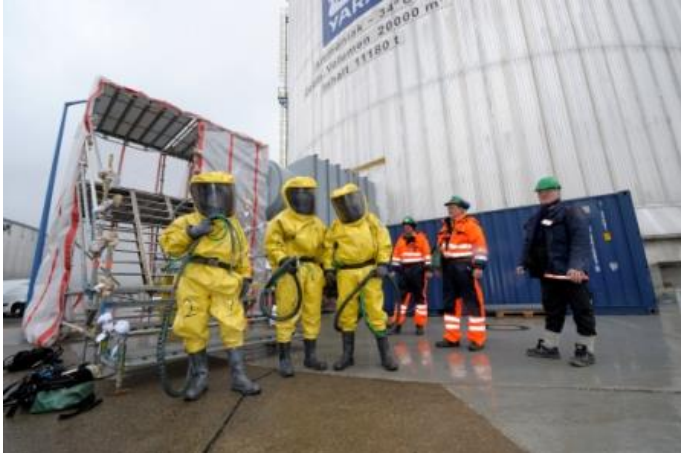
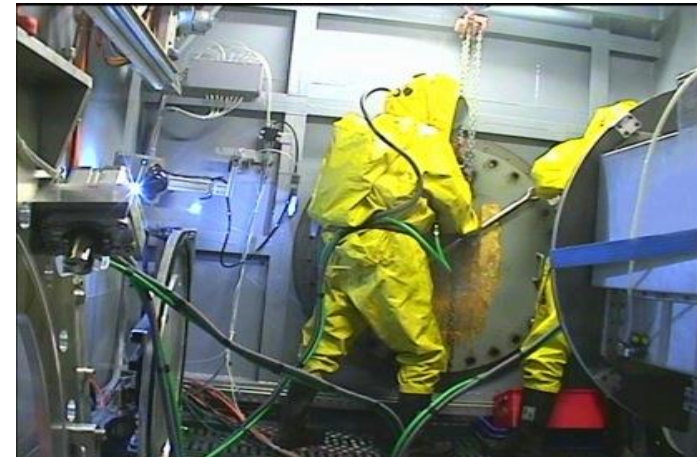
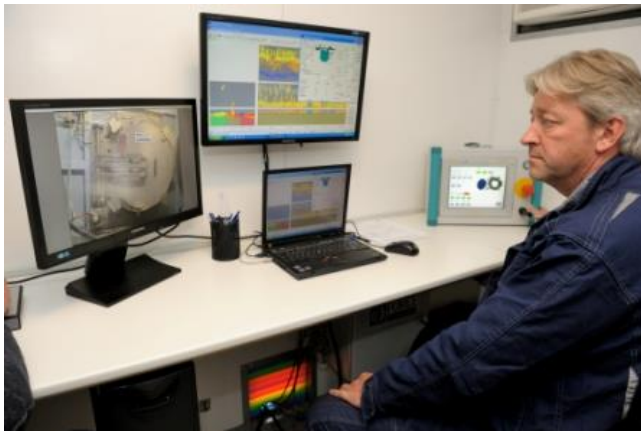
Inspection execution

- Inspection is carried out by a team of specialists consisting of:
 - NDT technicians
 - Mechanics
 - Fire fighters especially trained for working under toxic atmosphere
- Inspection sequence
 - Ammonia tank is opened in nitrogen atmosphere
 - The deployment tool with the remote controlled hatch is mounted
 - Hatch is closed
 - The atmosphere is normalized and the remaining equipment is mounted and tested
 - The habitat is filled with nitrogen and the inspection robot is placed on the external surface of the inner tank wall (“cup”) with the deployment tool
 - Hatch with cable reel is closed and the inspection begins
